## Case study: Damp survey:

MC Leak Detection has attended the property to carry out a damp survey

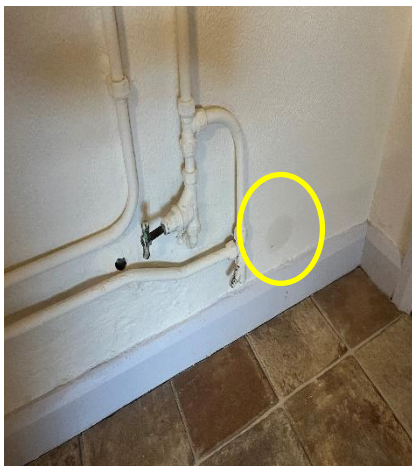
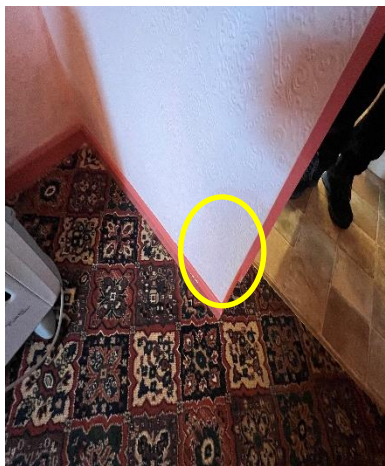
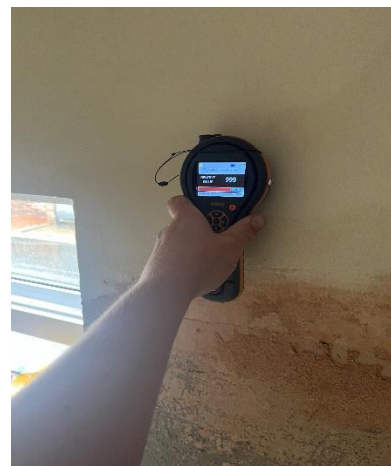
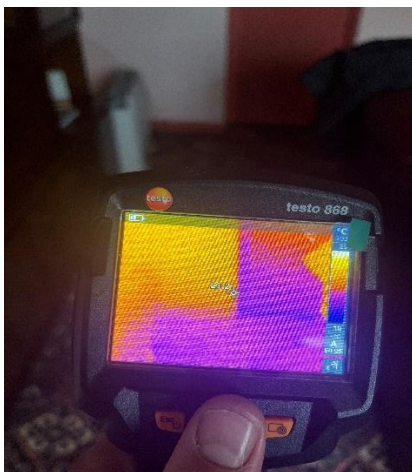
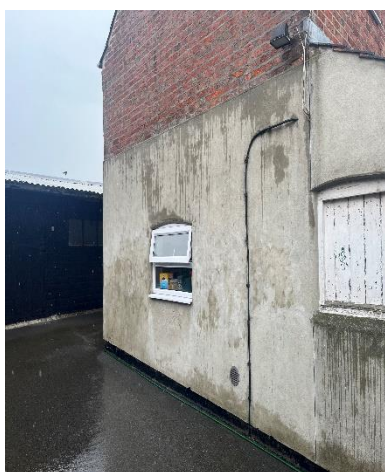
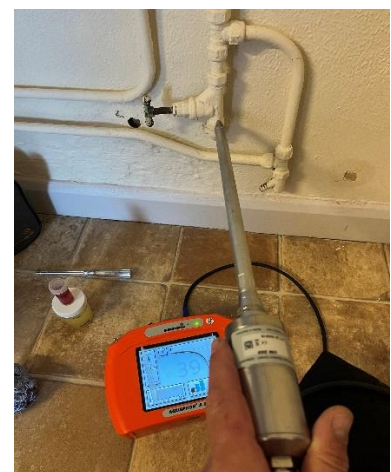
The property owner recently noticed damp staining in several rooms throughout the property. The affected areas do not visibly look consistent with an escape of water. Thermal imaging and acoustic testing suggested the issue is not related to a plumbing issue. The affected areas all contain high moisture content.

MC Leak Detection has concluded, the damp to the lower walls reported by the insured, is related to a pre-existing rising damp issue throughout the ground floor. We found no evidence of an escape of water or plumbing issue relating to the damage.

- **A PCA accredited damp specialist should attend to carry out a survey, to advise the property owner on the best course of action to remedy the damp issue throughout the ground floor.**

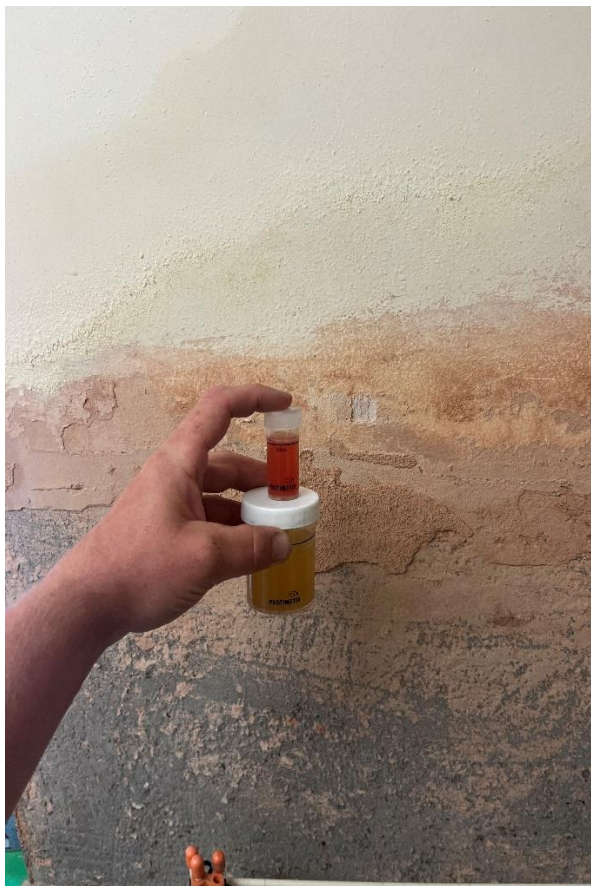
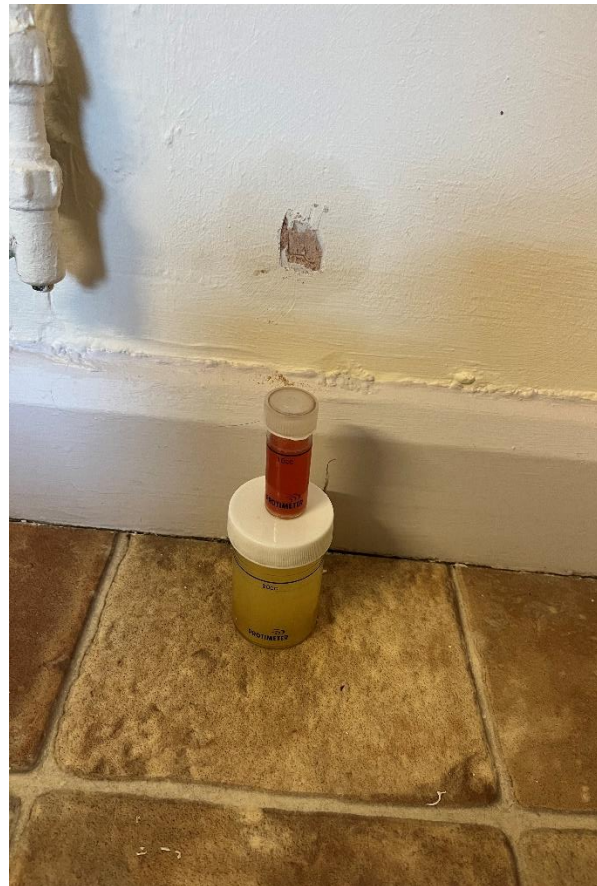
We took samples of the affected walls in the utility & kitchen to determine the source of moisture. The salts tests in each affected room resulted positive for nitrates. These results are consistent with the moisture being historical and from the earth below. The property is over 100 years old and likley has damp rising from the ground up the walls.
