Case study: Failed shower sealant:

MC Leak Detection has attended the property to carry out a leak detection survey

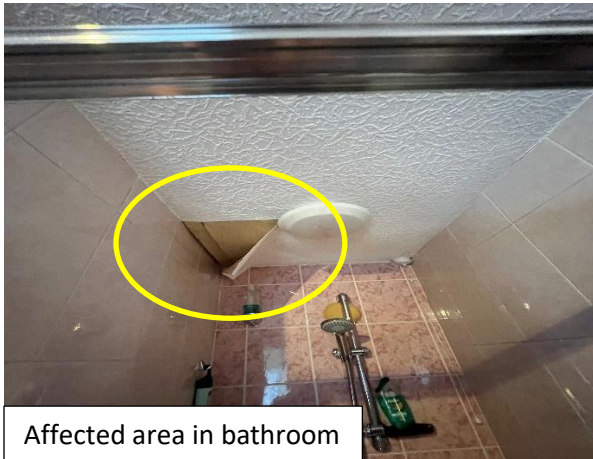
The property owner recently noticed water damage to the ceiling above the shower in the main bathroom on the ground floor. The affected area is below the en suite shower. A visual inspection of the en suite shower found the seals/grouting to be in poor condition.

Affected area in bathroom

- **The en suite shower wall tiles should be removed and regouted.**
- **The shower tray/screen should be resealed.**
- **When the above have been undertaken, the affected area below should be reinstated.**

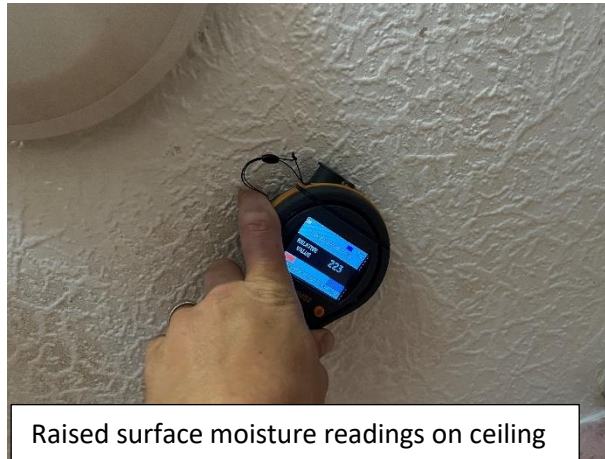
Raised surface moisture readings on ceiling

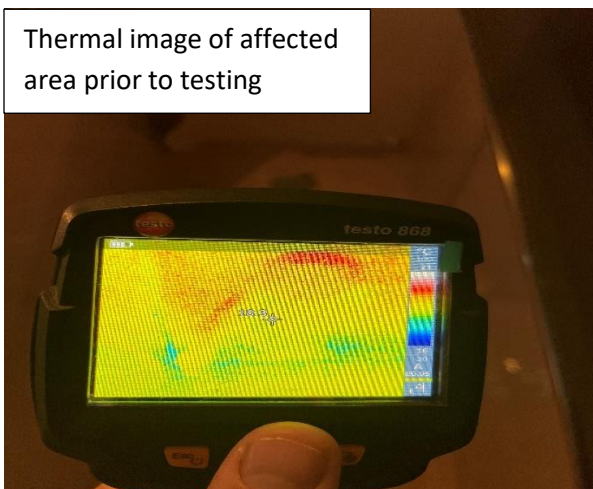
Thermal image of affected area prior to testing

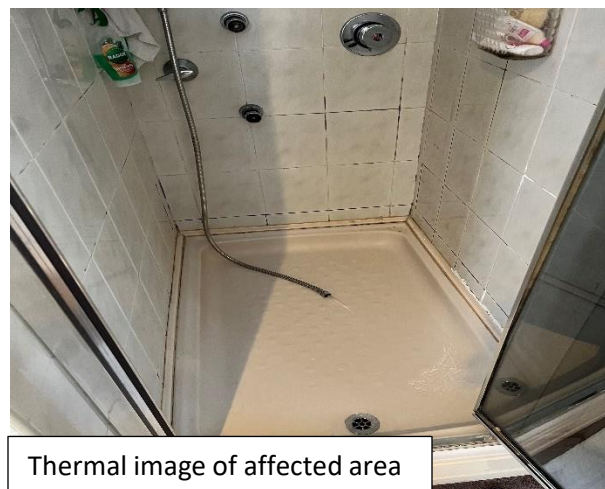
Thermal image of affected area

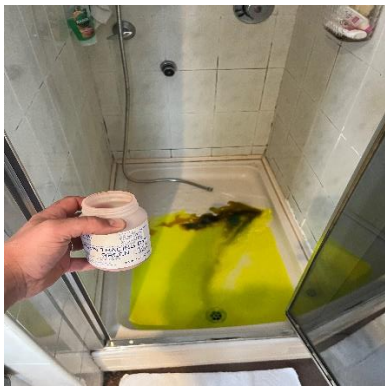
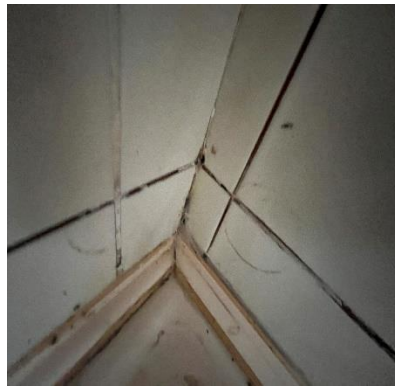
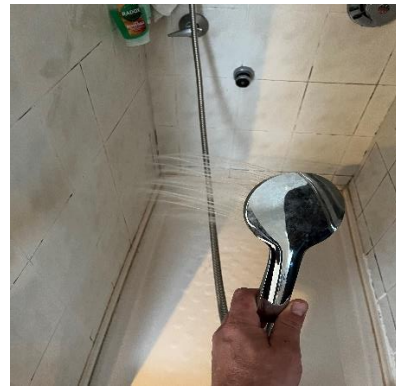
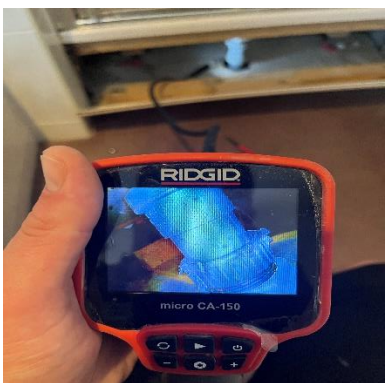
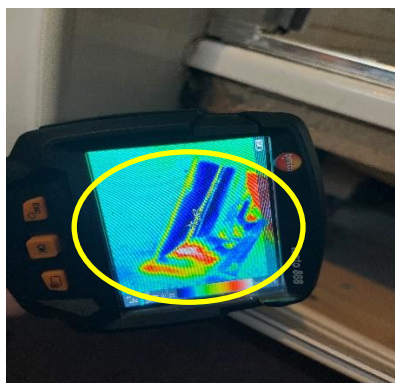
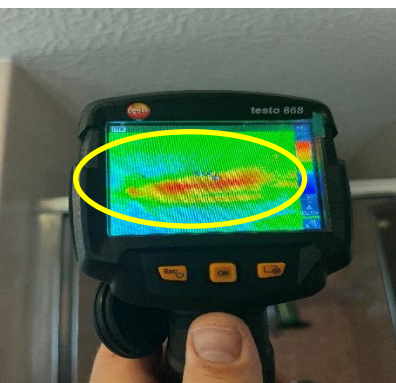
We dye tested the en suite shower waste and found no leaks on the waste pipe. A flood test of the shower wall/tray seals, found an immediate escape of water. After only a couple of minutes of flood testing, we found water emerge in the affected area of the ceiling below. It became clear the damage is wear and tear due to worn sealant within the en suite shower.

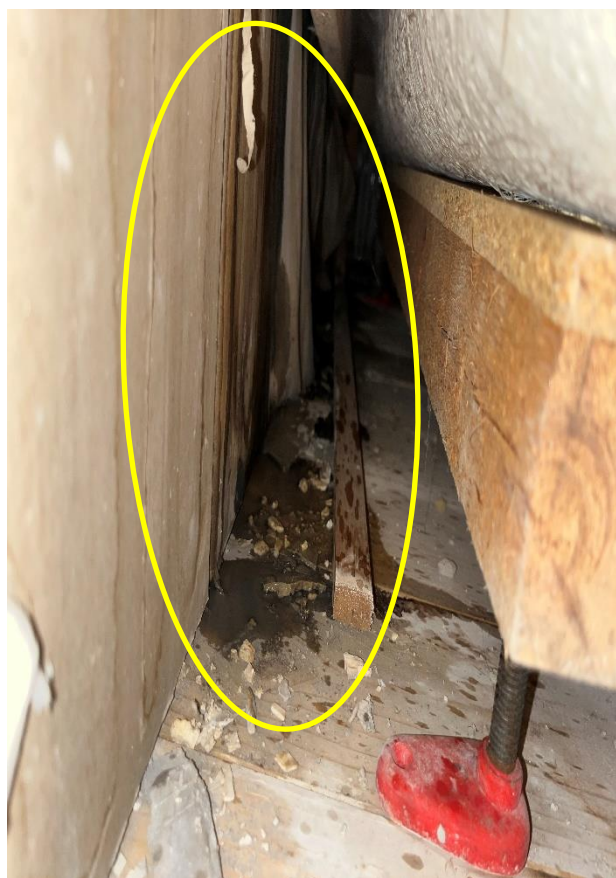
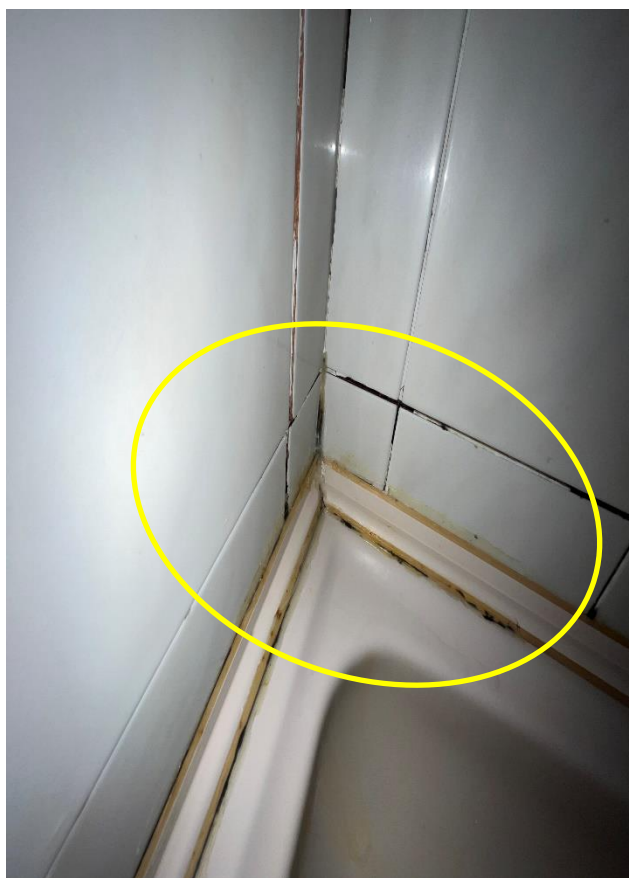
Water is escaping through failed sealant/grouting in the en suite shower, quickly progressing to the ceiling of the main bathroom below.

MC Leak Detection has concluded, the cause of damage to the bathroom ceiling is related to wear and tear on the seals/grouting in the en suite shower directly above.
