Case study: Thermal imaging:

MC Leak Detection has attended the property to carry out a leak detection survey

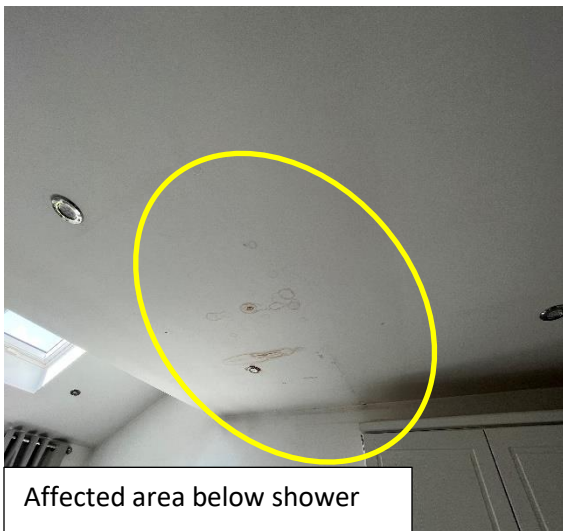
The property owner advised of a continual issue below the shower that is affecting the lounge ceiling in the extension. They have resealed the shower however, the issue is still ongoing. When we arrived, we found water staining to the lounge wall and water damage to the floor tiles outside of the shower cubicle. The damage seemed consistent with sealant failure.

Affected area below shower

- **Shower tray and floor tiles to be removed to enable inspection of timber structure beneath.**
- **A BDMA qualified drying technician should attend to carry out a survey.**
- **Once necessary strip outs and drying are complete, the shower area can be reinstated, and the affected area below redecorated.**

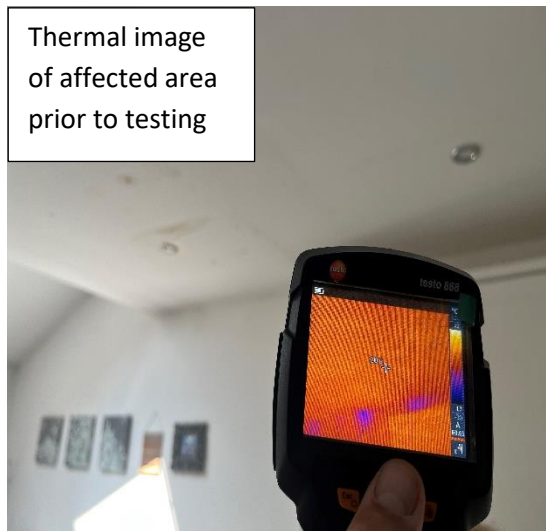
Thermal image of affected area prior to testing

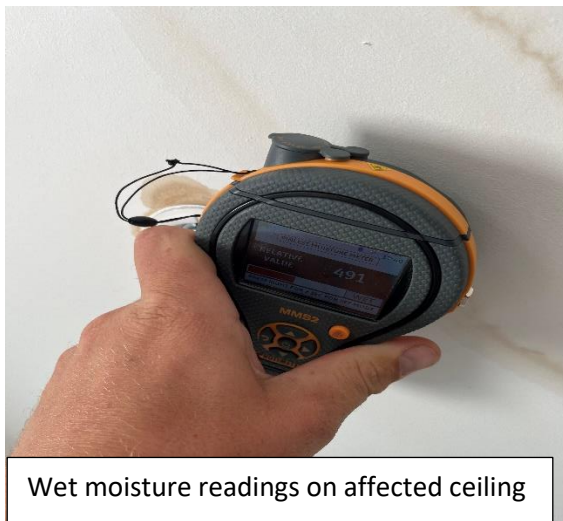
Wet moisture readings on affected ceiling

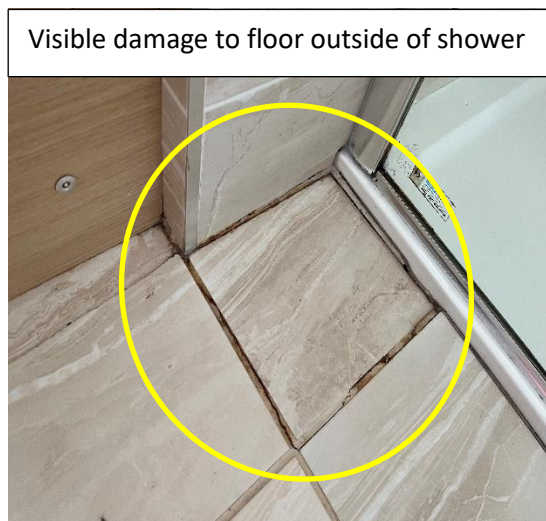
Visible damage to floor outside of shower

MC Leak Detection has concluded, the water damage to the property is related to a long-term failed sealant issue. The homeowner recently sealed the shower, so we are unable to comment on the condition of the previous seal. The floor below the shower is likely to be in poor condition due to sustained water ingress over a long period. This is evident to some of the floor tiles outside of the shower where they have cracked in several places. Given the likely condition of the floor below the shower, merely resealing the shower will not rectify the issue in our opinion. The shower tray and floor tiles will need to be removed to enable a thorough inspection of the timber floor beneath which may need to be replaced to ensure the shower is watertight going forward.

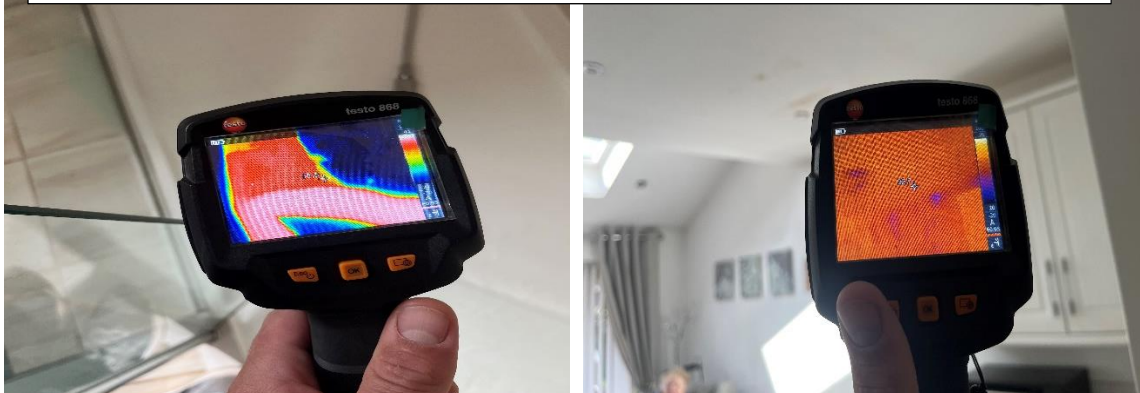
We flow tested the shower waste with hot water and found no change in the thermal image of the affected area below the shower to the extension lounge ceiling

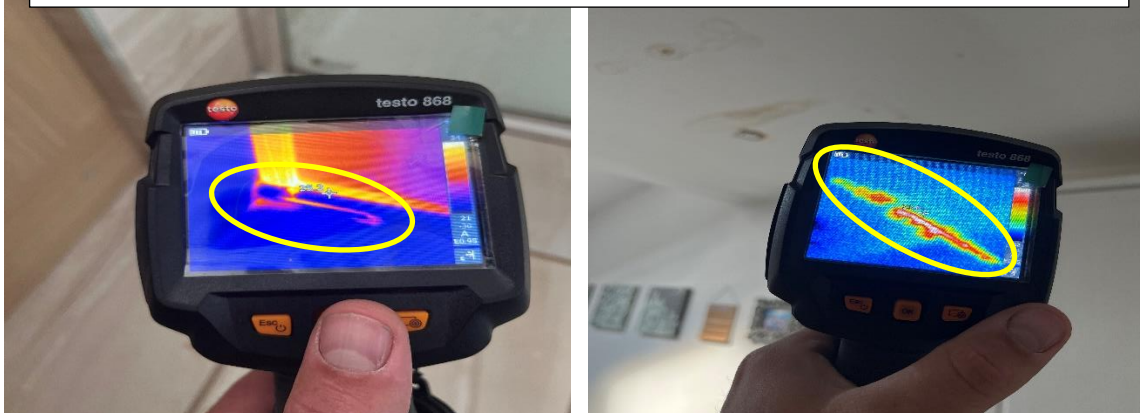
We tested the shower waste and found no change in the thermal image of the affected area. A flood test of the shower seals found water immediately escaping through to the affected area of bathroom floor and then onto the ceiling below. It was clear the damage has been caused by failed sealant.

We flood tested the shower seals and found water immediately escaping through the suspect corner of the shower. Water then emerged in the affected area of ceiling below
