## Case study: Damp survey:

MC Leak Detection has attended the property to carry out a damp survey

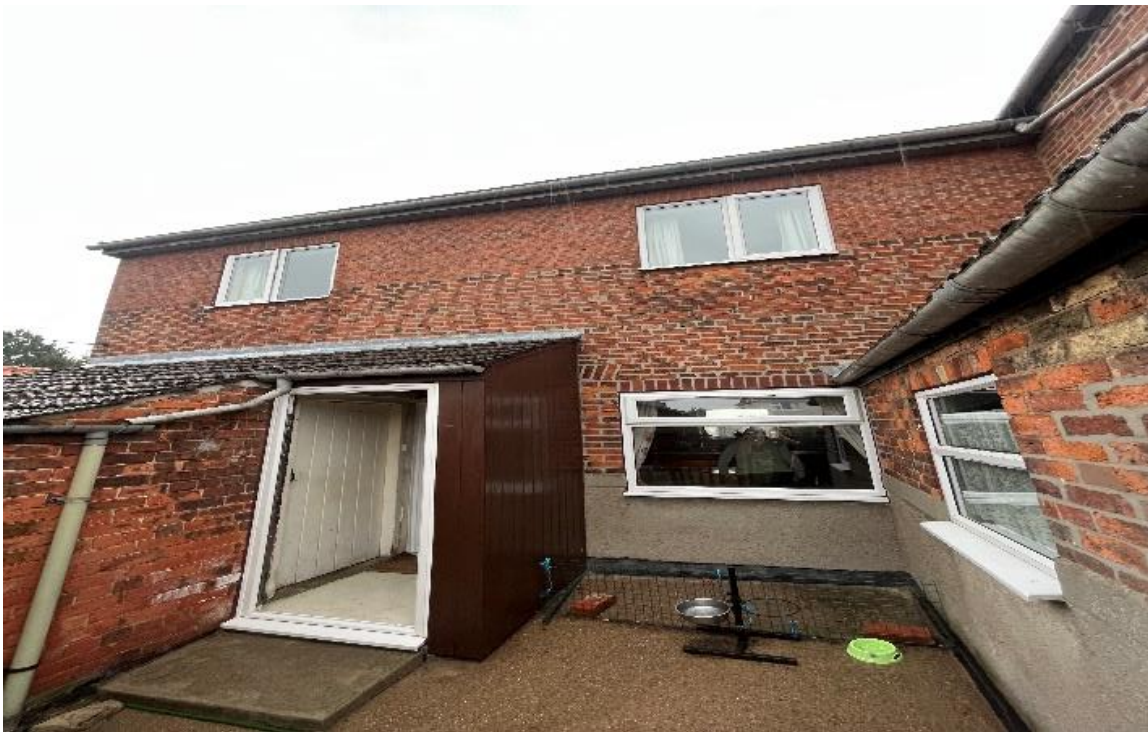
The property owner recently noticed damp staining in several rooms throughout the property. The affected areas do not visibly look consistent with an escape of water. Thermal imaging and acoustic testing suggested the issue is not related to a plumbing issue. The affected areas all contain high moisture content.

MC Leak Detection has concluded, the damp to the lower walls reported by the insured, is related to a pre-existing rising damp issue throughout the ground floor. We found no evidence of an escape of water or plumbing issue relating to the damage.

- **A PCA accredited damp specialist should attend to carry out a survey, to advise the property owner on the best course of action to remedy the damp issue throughout the ground floor.**
