Case study: Failed shower sealant:

MC Leak Detection has attended the property to carry out a leak detection survey

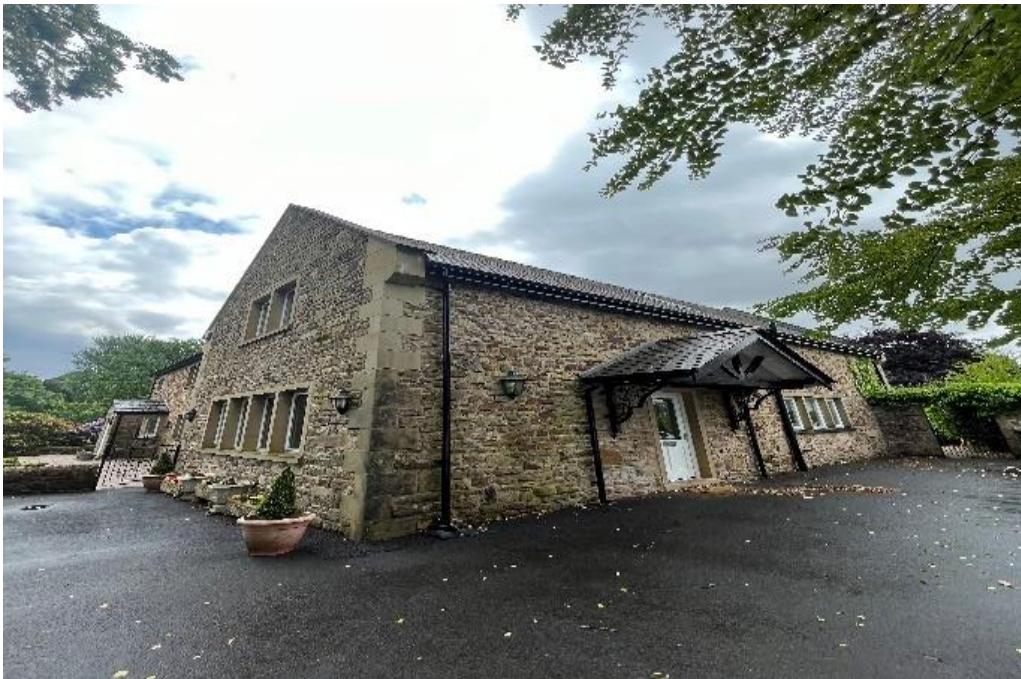
The property owner recently noticed water damage to the ceiling above the shower in the main bathroom on the ground floor. The affected area is below the en suite shower. A visual inspection of the en suite shower found the seals/grouting to be in poor condition.

Water is escaping through failed sealant/grouting in the en suite shower, quickly progressing to the ceiling of the main bathroom below.

MC Leak Detection has concluded, the cause of damage to the bathroom ceiling is related to wear and tear on the seals/grouting in the en suite shower directly above.
